ISTAIR Product Evaluation Report and Test Data

ISTAIR™ System

i18gs, i20gs and trg45 I-Stair Bracket
Concentrated Load Testing

Step Load Cycle Test

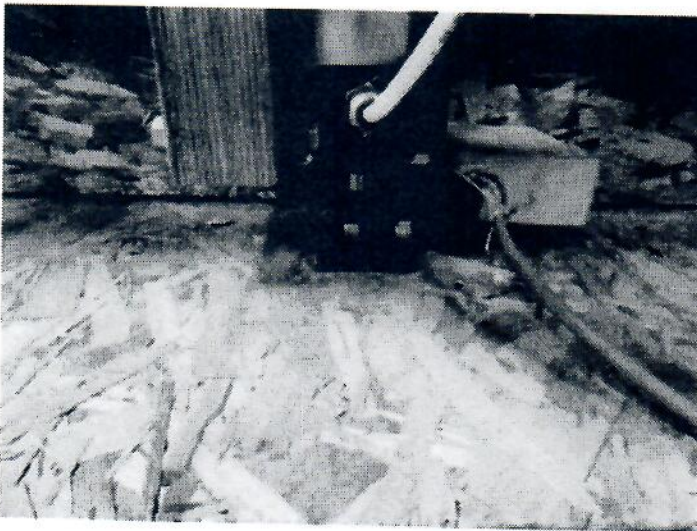
2" x 2" loading nose

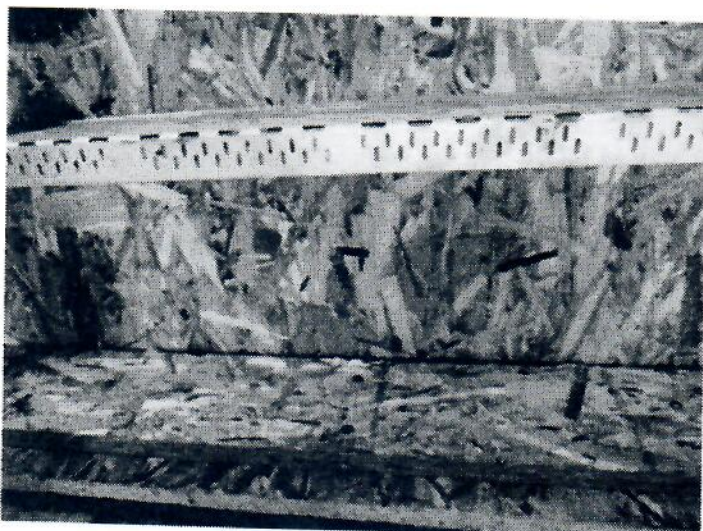
Gangnail brace after 1,000,000+ cycles

Conclusion: The stair-cycle test was a success, with no failures occurring, as well as no visual damage to the I-Stair brackets or gang nail brace. The tread surface in contact with the loading nose was slightly indented by 2x2 loading plate and had a few loose or frayed strands around the perimeter of the loading plate. The actual permanent set and deflection under load may vary from that shown at the completion of the test, due to the shifting in the sample on 6/17/16, however it was included to show that there was no significant material breakdown.

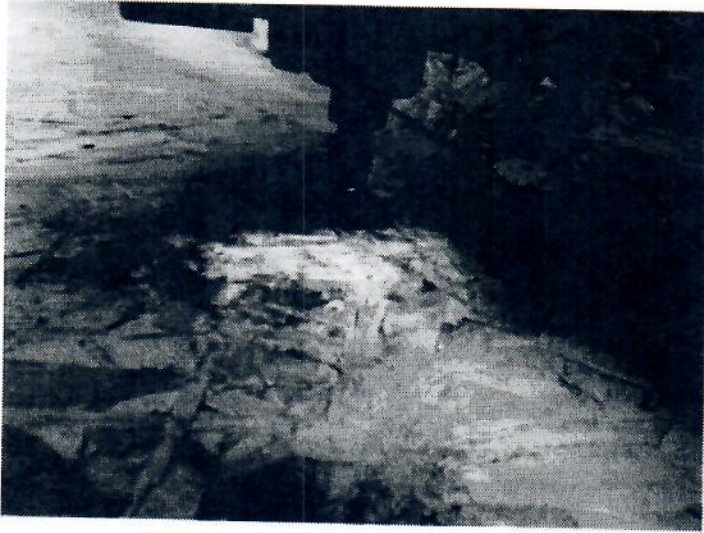
Tread surface after 1,000,000 cycles
