I-STAIR SYSTEMS, INC.

i18gs, i20gs and trg45 I-Stair Bracket
Concentrated Load Testing

2011-404

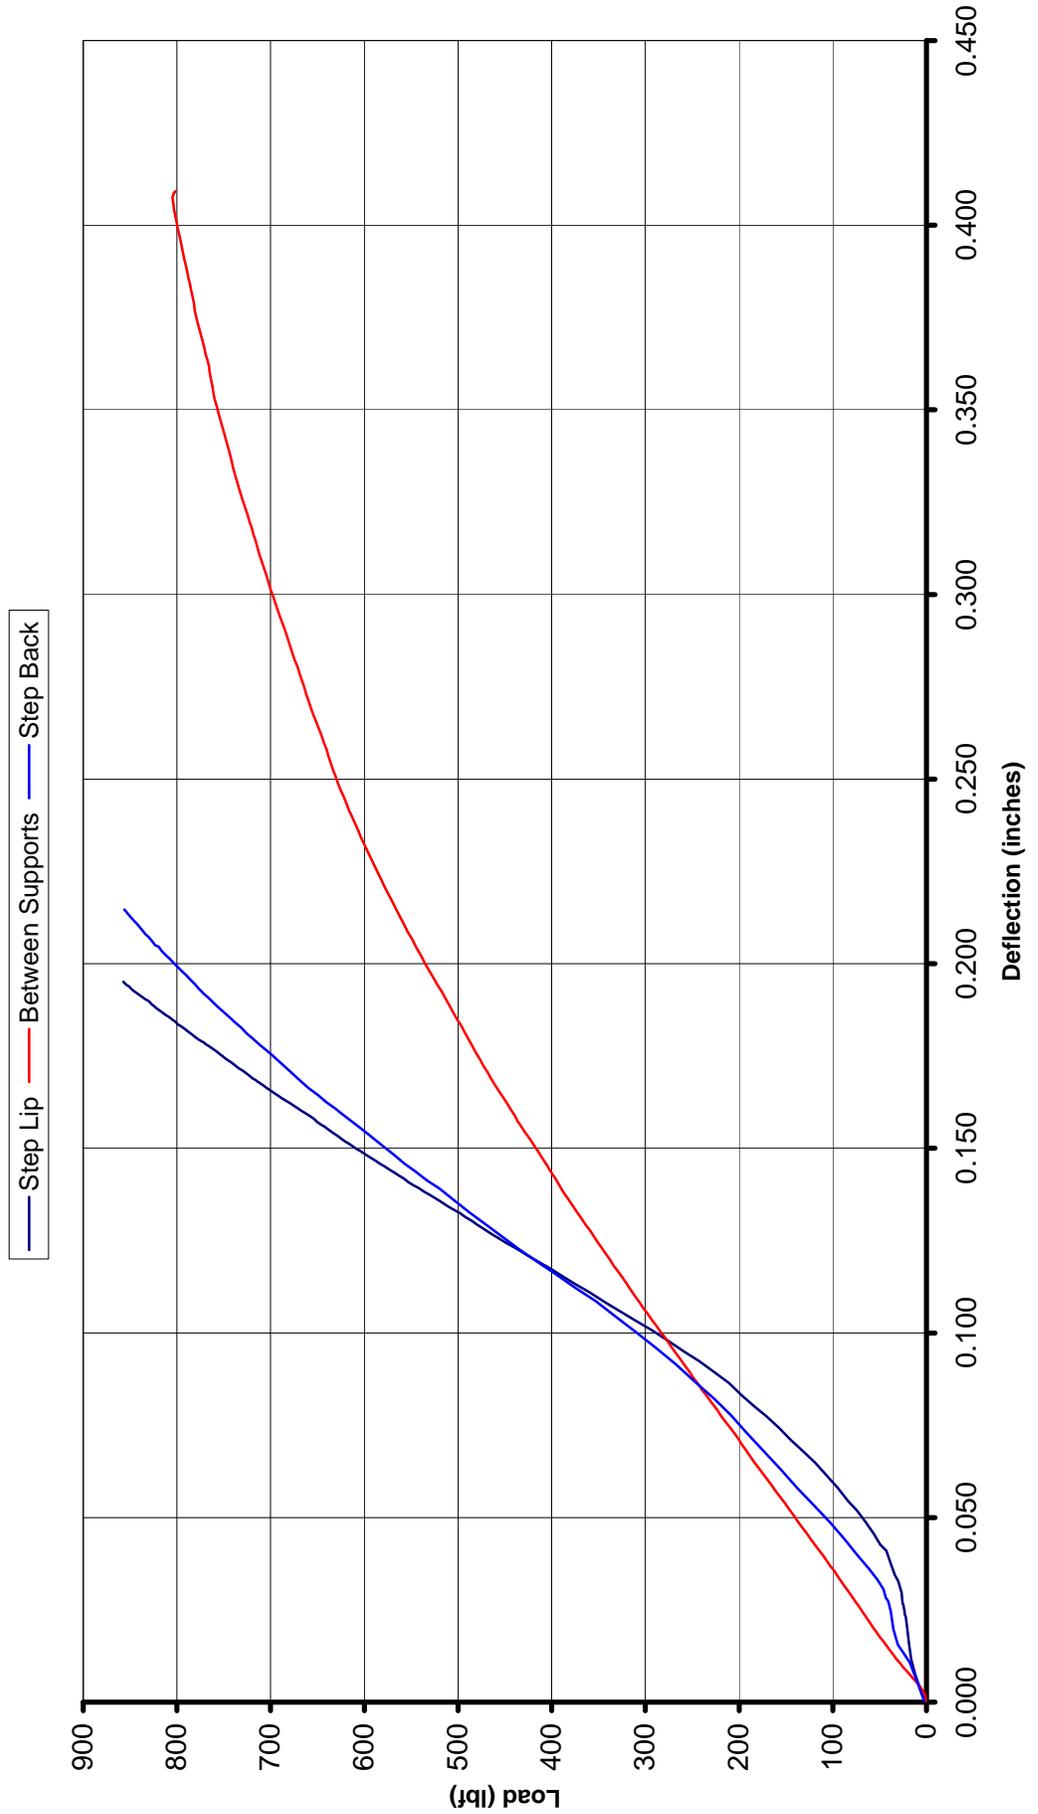
**I-Stair Systems
2x2" Concentrated Load
Load versus Deflection
i18GS I-Stair Bracket and trg45**

Test Location / Deflection ¹ (in)			
Load (lbf)	Step Lip	Step Back	Between supports
200	.086	.078	.071
300	.103	.100	.107
400	.117	.119	.144
500	.133	.136	.185
600	.149	.155	.232
700	.166	.177	.303
800	.184	.200	.401

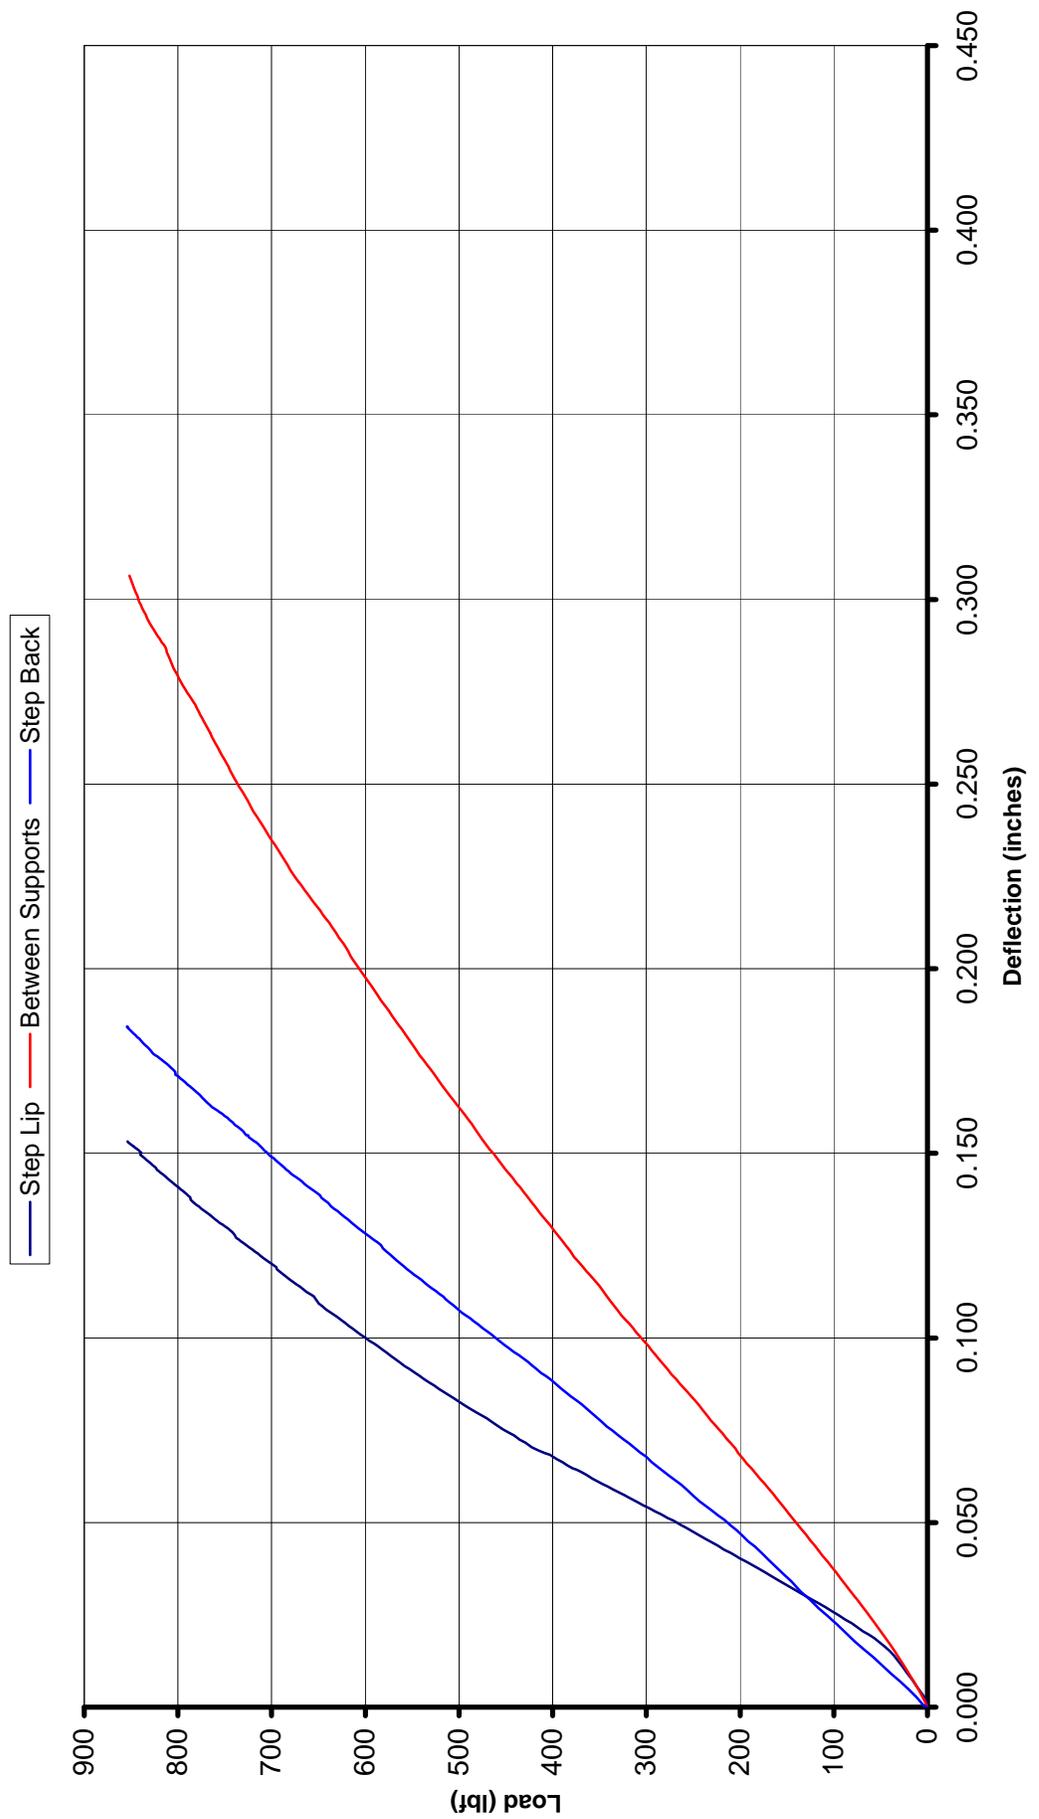
**I-Stair Systems
2x2" Concentrated Load
Load versus Deflection
i20GS I-Stair Bracket and trg45**

Test Location / Deflection ¹ (in)			
Load (lbf)	Step Lip	Step Back	Between supports
200	.040	.048	.069
300	.055	.068	.099
400	.068	.089	.130
500	.084	.108	.163
600	.100	.129	.198
700	.120	.149	.235
800	.141	.171	.280

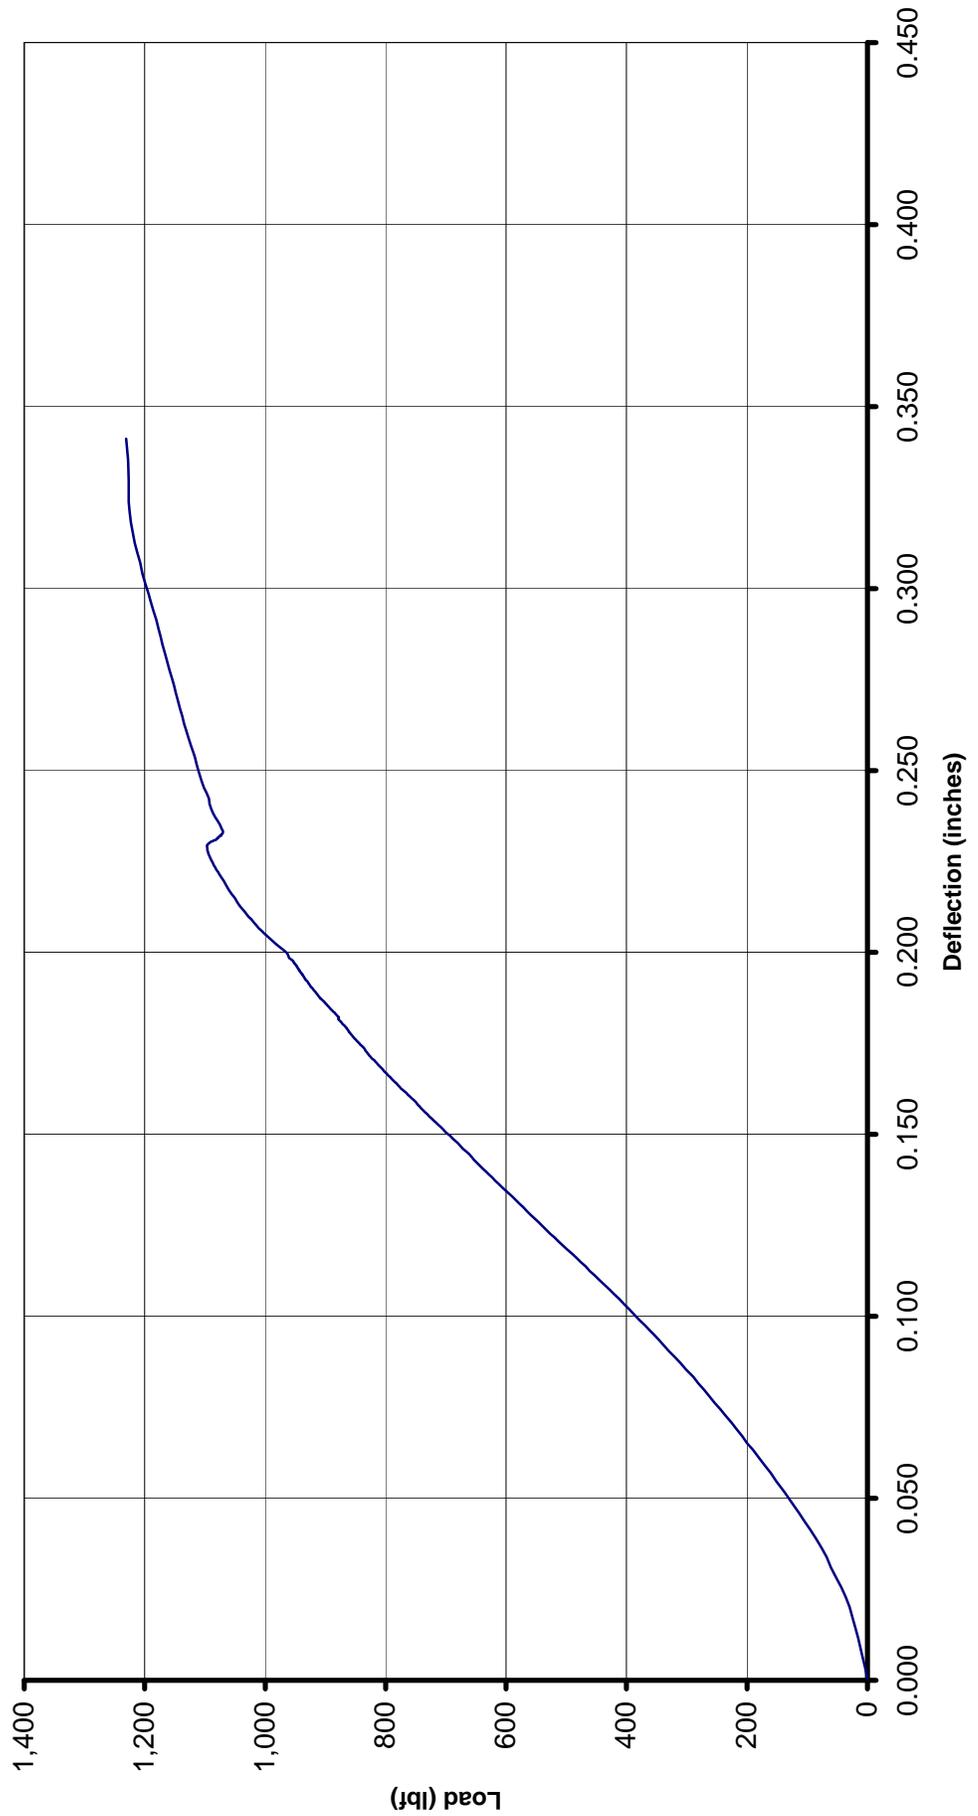
**I-Stair Systems
2x2" Concentrated Load
Load versus Deflection
i20GS I-Stair Bracket and trg45**

— Step Lip to Failure

Load (lbf)	Deflection ¹ (in) Step Lip to Failure
200	.067
300	.085
400	.103
500	.119
600	.135
700	.151
800	.167
900	.186
1000	.205
1100	.245
1200	.304
1300	.436
1400	.762

During loading, the bracket directly under the loading nose started to deform at the lower portion of the bracket. Load was applied until a loss of load, and no subsequent load gains were noted. See failure pictures for further details.

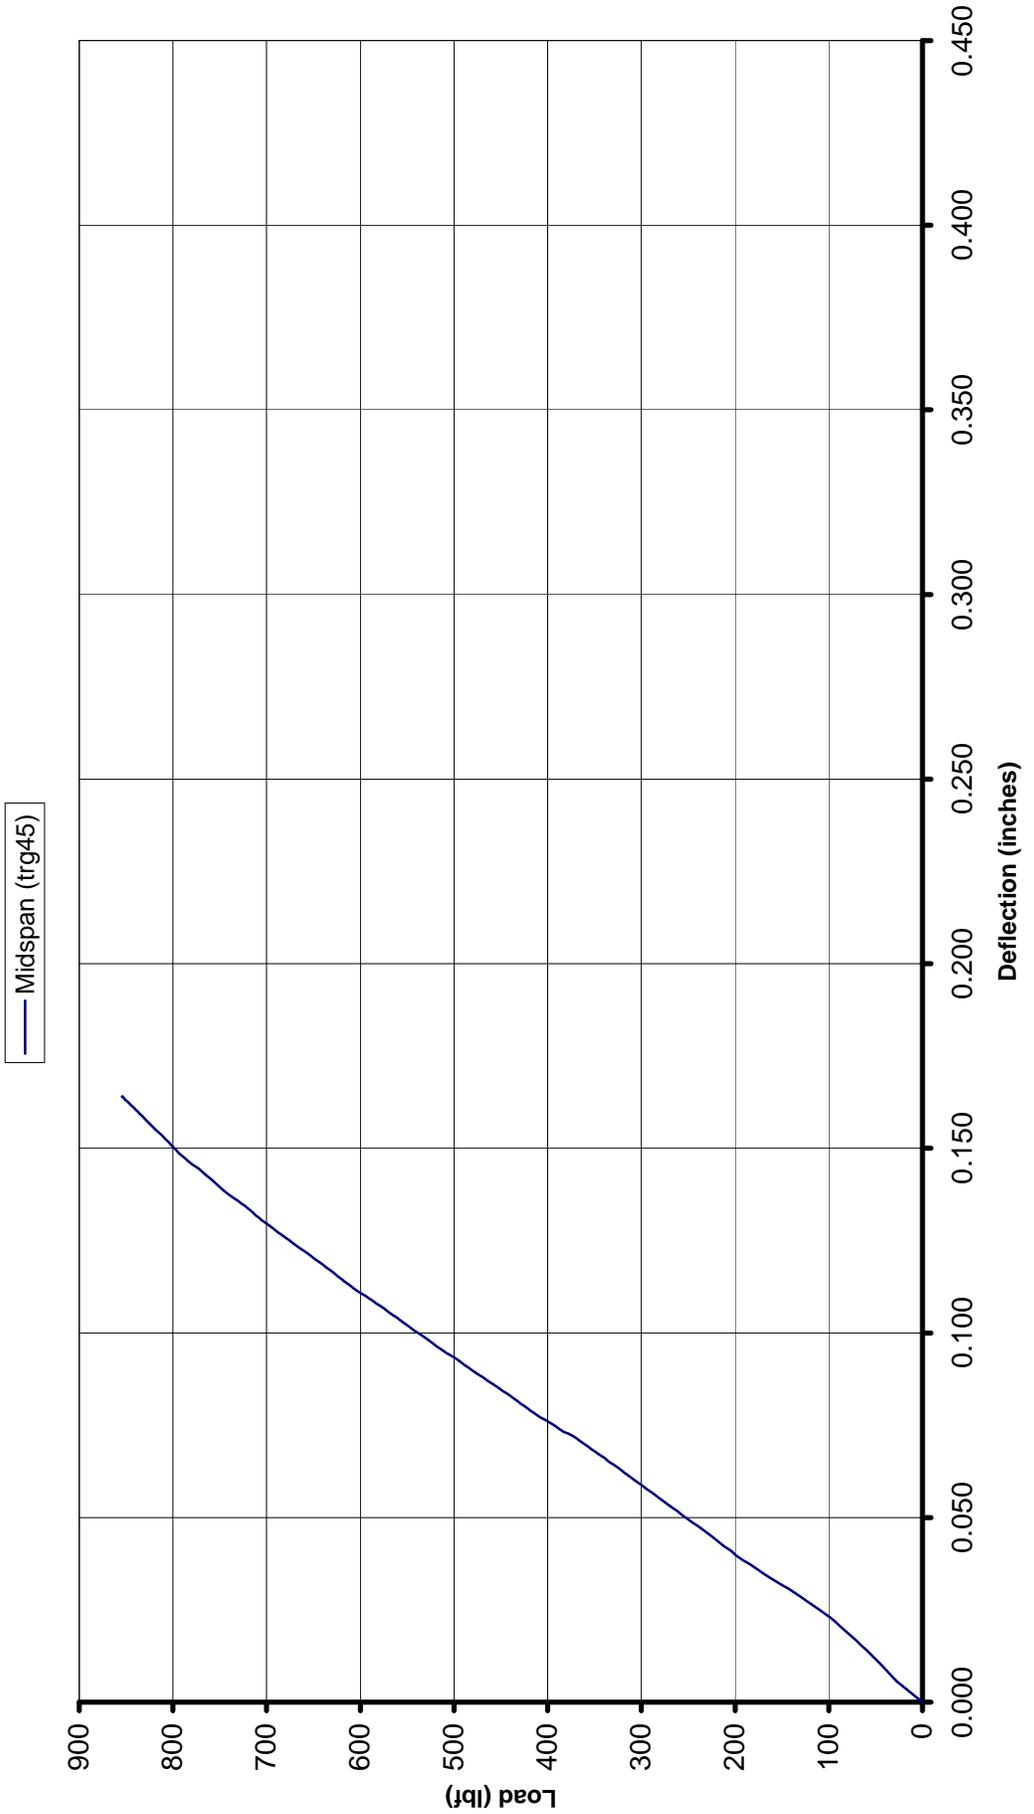
**I-Stair Systems
2x2" Concentrated Load
Load versus Deflection
trg45" I-Stair Bracket**

Deflection ² (in)	
Load (lbf)	Midspan - trg45
200	.041
300	.059
400	.077
500	.094
600	.111
700	.130
800	.150

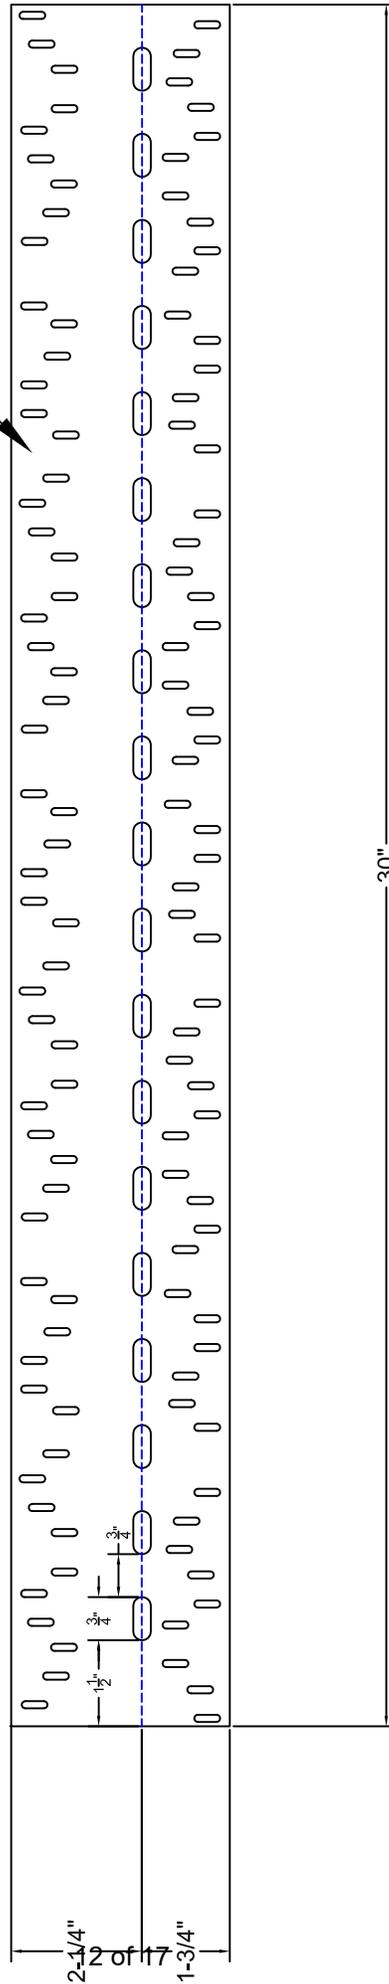
DRAWN BY: J. BONTRAGER	CLIENT:
DATE: 04/01/11	I-STAIR SYSTEMS
SCALE:	TITLE:
JOB NO. 2011-404	trg45 - TREAD RISER GUSSET
DWG. NO. B1	
REVISED ON:

3/4" SLOT @ BENT POINT

The trg45 consisted of a gang nail plate 30 inches long, with 3/4" slots at the bend point. The average measured thickness is .033". The gusset is intended for use with stair systems 45" wide.

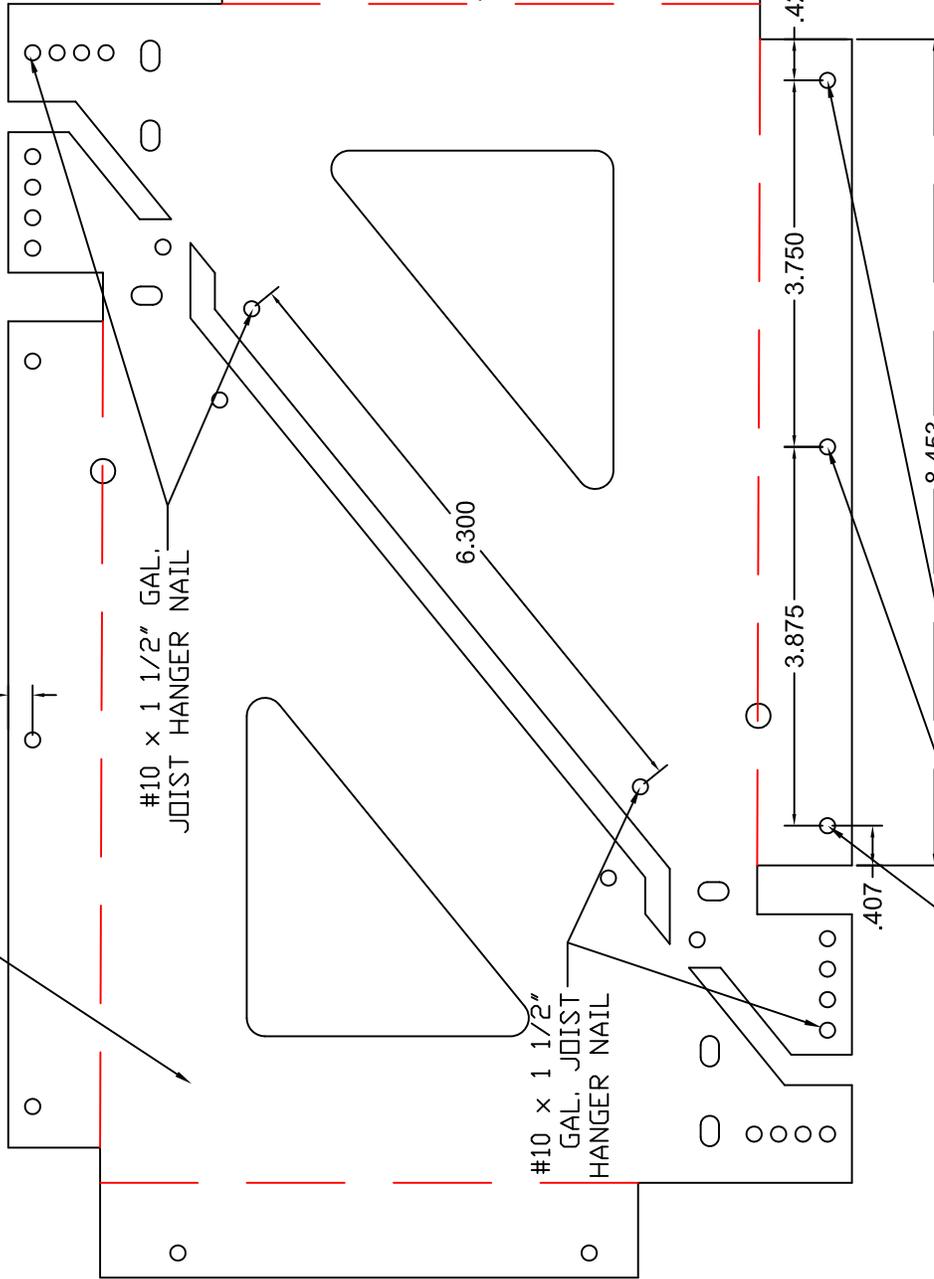
DRAWN BY:	REVISED ON:	CLIENT:
J. WITMER		I-STAIR SYSTEM
DATE: 3-29-11		TITLE:
SCALE:		118gs I-STAIR BRACKET
JOB NO. 2011-404		
DWG. NO. B2

THICKNESS: .036"

#10 x 1 1/2" GAL. JOIST HANGER NAIL

#8 x 3/4" FLAT BUGLE HEAD DRYWALL SCREW

The i18gs I-Stair Brackets consisted of triangular shaped galvanized steel with a triangular shaped cut-out in the center. The average measured thickness was .046". Two (2) 1" wide tabs, one (1) located on each side of the triangle, were folded at a 90° angle and fastened to the stair tread and the other to the stair riser. See attached drawing B2 for details.

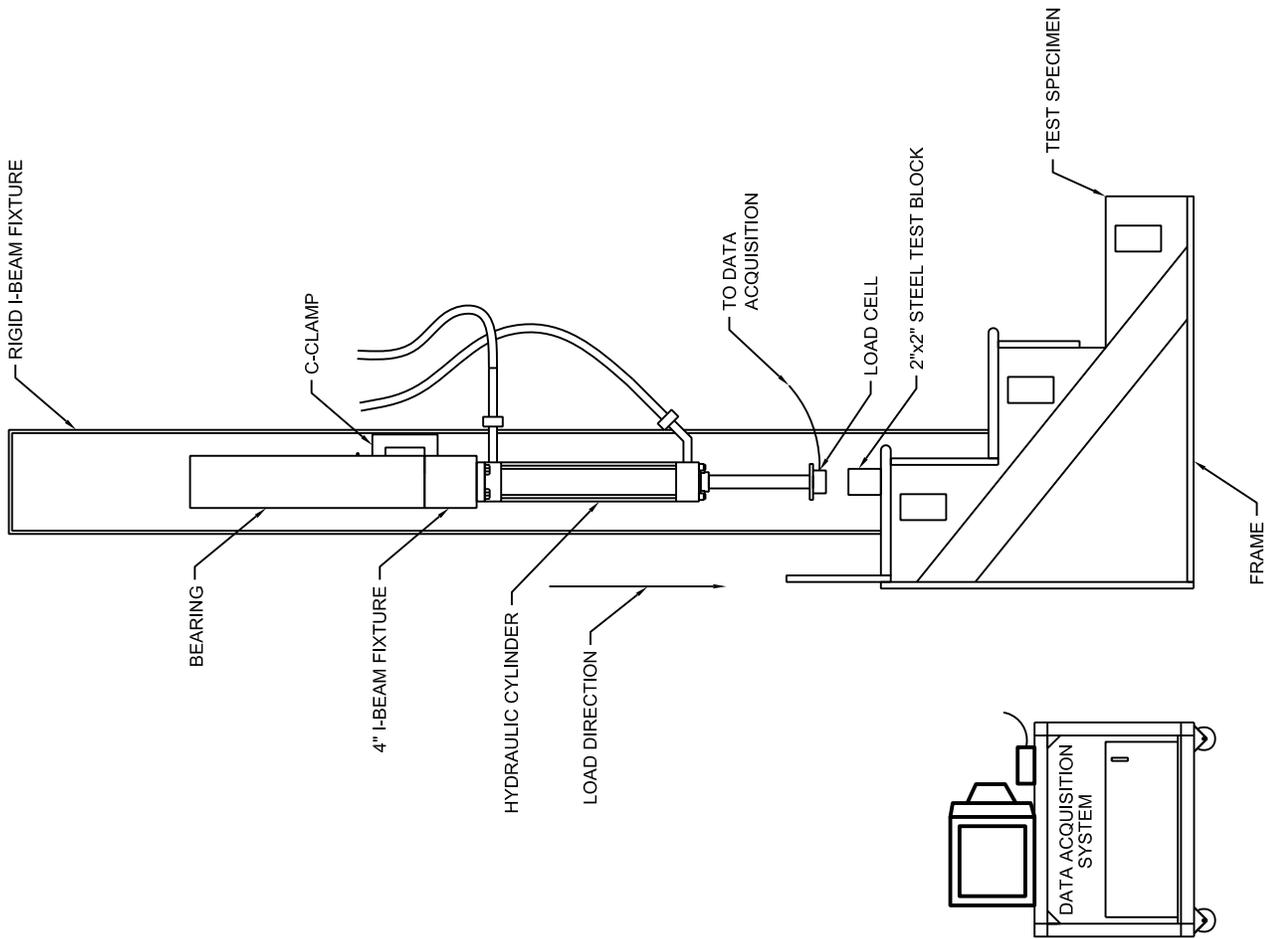
SIDE VIEW

A hydraulic cylinder was positioned above the test specimen, in the desired location, with a load cell, and a 2.000" x 2.000" loading block inline. A linear transducer was set to measure the deflection of the hydraulic cylinder at the load point, and two other were used to subtract out the system deflection. The system deflection was defined as movement not directly related to the loaded parts, such as the test specimen support at the base and the stringer deflection. The Data Acquisition System was set to record the Load and Deflection throughout the tests. See attached fixture Drawing No. F1765 for details.

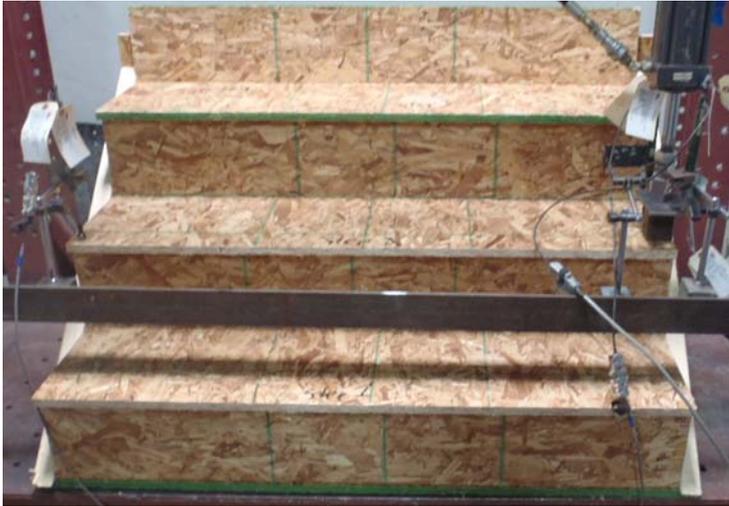
Typical test setup

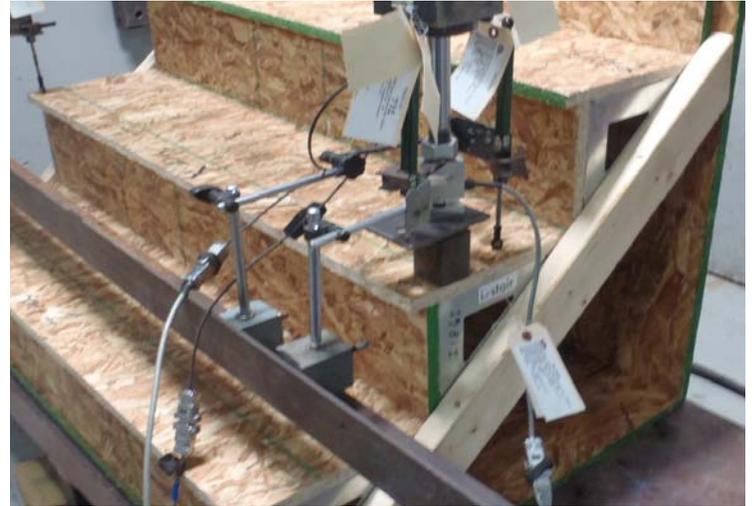
Typical test setup

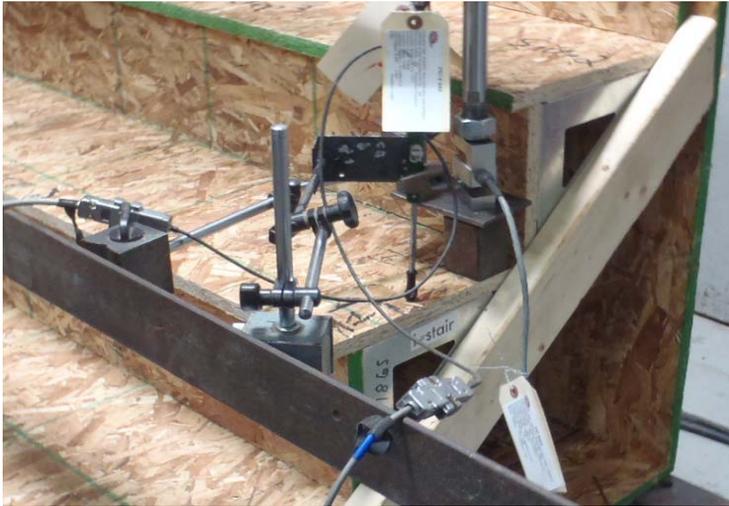
Testing back location

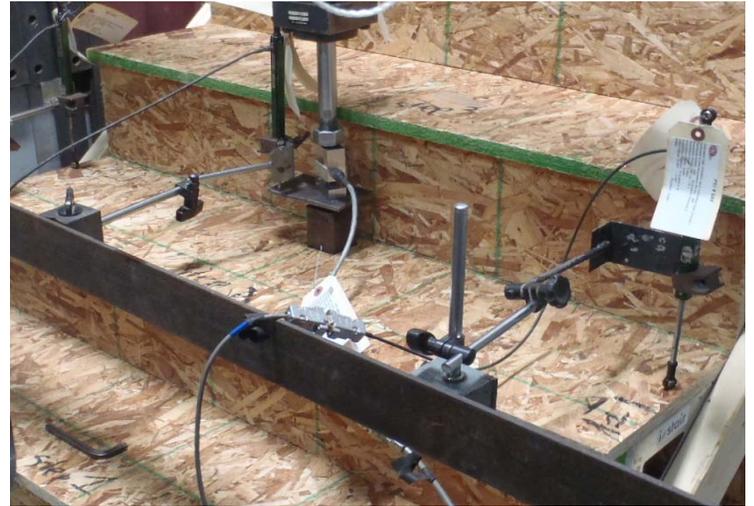
Testing midspan back location

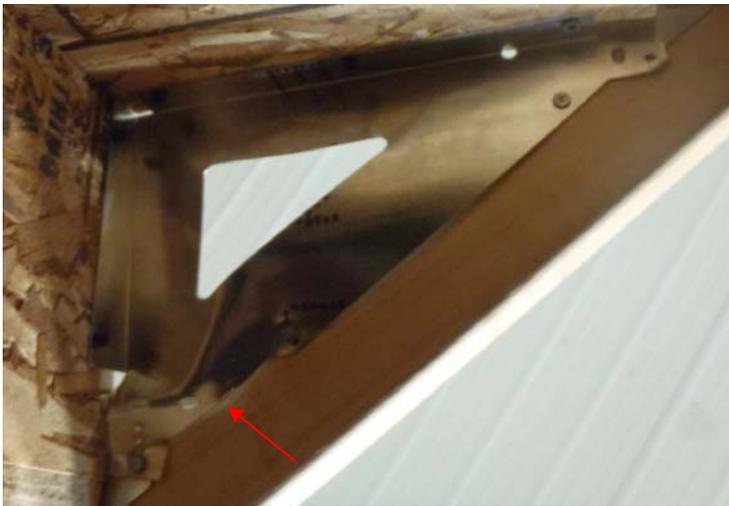
Ultimate load failure mode

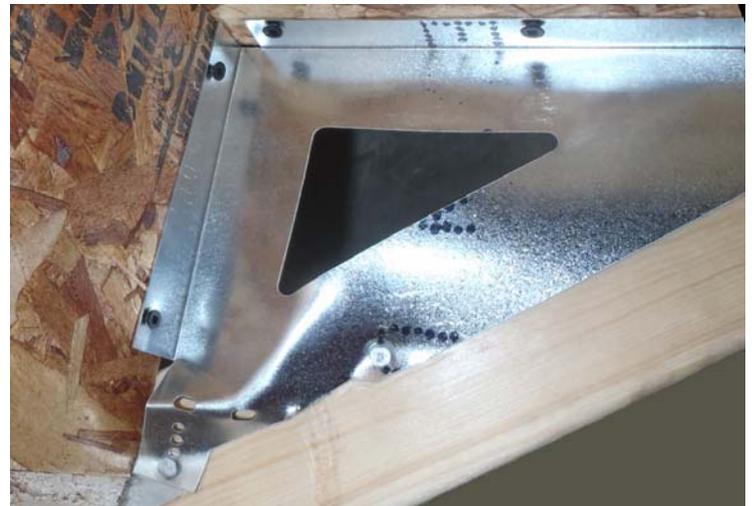
Ultimate load failure mode
